Caring for old floors

Advice from the SPAB

History at your feet: care and repair of old floors

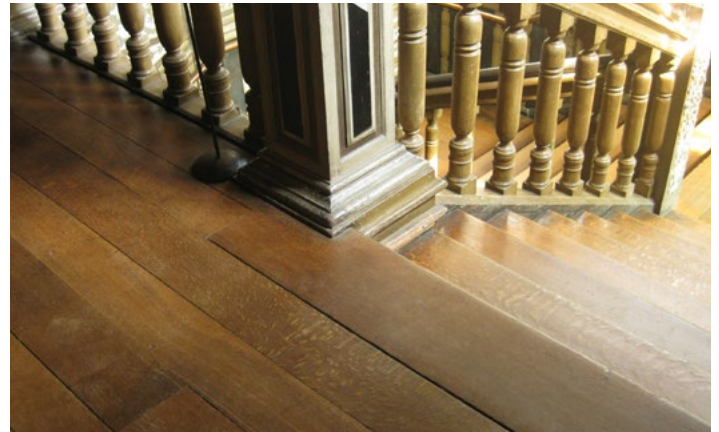
Left image: the underside of wooden floorboards at Gladstone's Land, Edinburgh. Credit: National Trust for Scotland

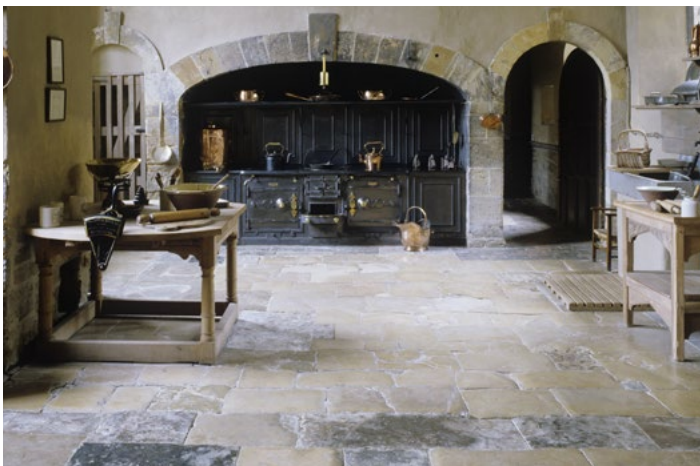
Images: Banner - Chapel at Lytes Carey, Somerset. Credit: Kate Griffin. Left - Elizabethan flagstone at Canons Ashby, Northamptonshire. Credit: National Trust Images/Andreas von Einseidel.

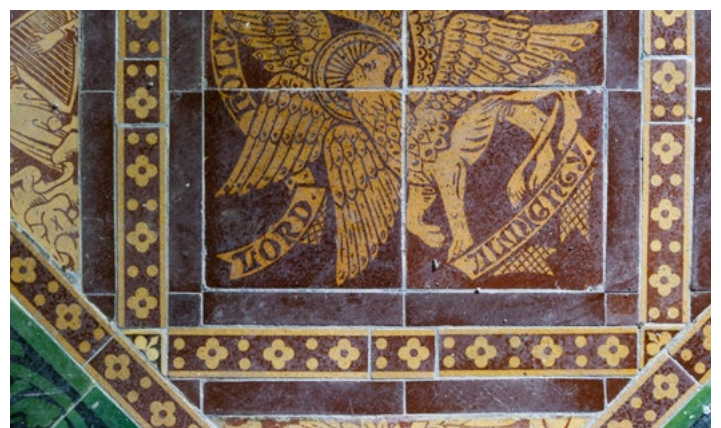
Images: Banner - Medieval tiles at All Saints Church, Icklingham, Suffolk. Credit: Peter Emina. Above - Victorian repairs to tiles at St Jerome, Llangwm Uchaf, Monmouthshire. Credit: Friends of Friendless Churches.

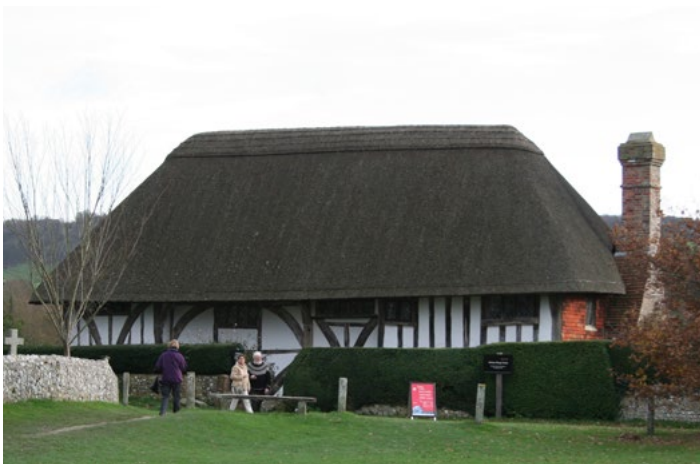
The chalk floor of the Medieval Great Hall of the Clergy House at Alfriston, owned by the National Trust, was renewed in 1998. Fine dusty chalk from a local quarry was laid and compacted to produce a smooth surface.

Large chalk aggregate at the surface was thought to be the reason for the failure of the previous floor. Thirty gallons of unpasteurised sour milk was poured over the chalk floor and left to soak in. An initial mould growth occurred, but this has subsequently died back. It took several months for the floor to solidify and harden but it has since withstood heavy visitor footfall.

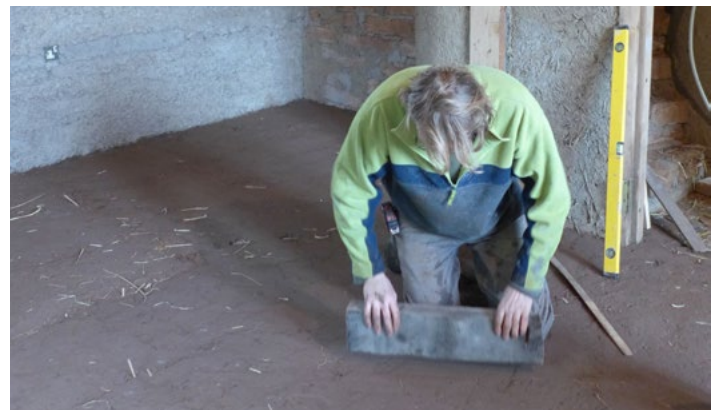
Earth floors, well consolidated and protected with a layer of rushes or straw, continued in use on the ground floors of humble cottages until the 18th century. Clay mixed with fresh ox blood and ashes formed a surface that was hard enough to be polished. Where still in existence, these floors can be repaired by raking the surface and incorporating high calcium lime and flyash or hydraulic lime depending on the clay content of the earth floor. Many of the comments made in previous sections about not inhibiting breathing potential apply particularly to earth floors.

Images: Left - Alfriston Clergy House, Sussex. Credit: SPAB. Above - tamping an earth floor. Credit: Becky Little.
